HELICOPTER ACCIDENT REPORT NO. MTC/AIG/01/21

**Final Report on the fatal accident to
Robinson R44 Raven II helicopter, ZS-SBM at
Xumabee Game Ranch in the Western Sand
Veld, near Sojwe on 5 March 2021**

Aircraft Accident Report No: MTC/AIG/01/21

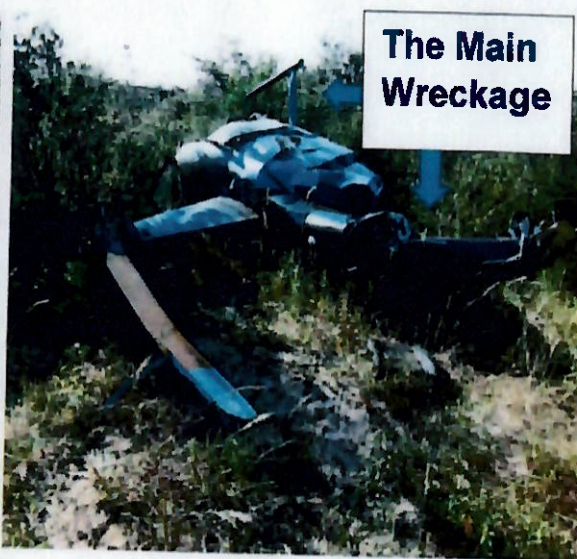
1.12.2 The main Instrument Panel was found along the skid marks trail at approximately 15 metres upstream of the main wreckage, with reference to the final trajectory. One of the instruments indicated that at the time of losing power (or when it got sheared off the aircraft) the helicopter was descending and banking to the left. Despite the fact that the time of occurrence was reported to be prior to 1700Z, the investigation discovered a mobile screenshot indicating that the passenger was last seen on the WhatsApp at 1704Z. The helicopter's clock was found showing the time captured as 1741Z. The clock's photograph is attached as **Appendix 3** to this report.

2.13.2.4 Fourth, it was noted that sunset was at 1637Z on the day of occurrence. The helicopter's clock showed the stoppage time to be 1741Z. This would make the actual time of crash to be at least an hour after sunset. This is consistent with the reports that employees could not easily locate the wreckage because it was dark. This was further confirmed by the witness who said he could see fellow employees' search light at a distance. It all points to the fact that the crash took place when the visibility was greatly compromised and this was compounded by the fact that it was the PIC's first time to fly to his Ranch that very late. His training records revealed that he had accrued approximately 12 hours of night flying, but they were all dual with no solo flight recorded. Not only that, but flying at night around the Gauteng Province cannot compare with flying at night in the Western Sand Veld. At Gauteng one has the advantage of street lights (together with moving vehicles' lights) and at Western Sand Veld features were different and if it was the first time for the PIC to be flying in the area at night, the possibility of spatial disorientation cannot be ruled out.

The Helicopter's Clock recording the loss of power as 1741Z, suggesting the crash time to be 1740Z or thereabout!

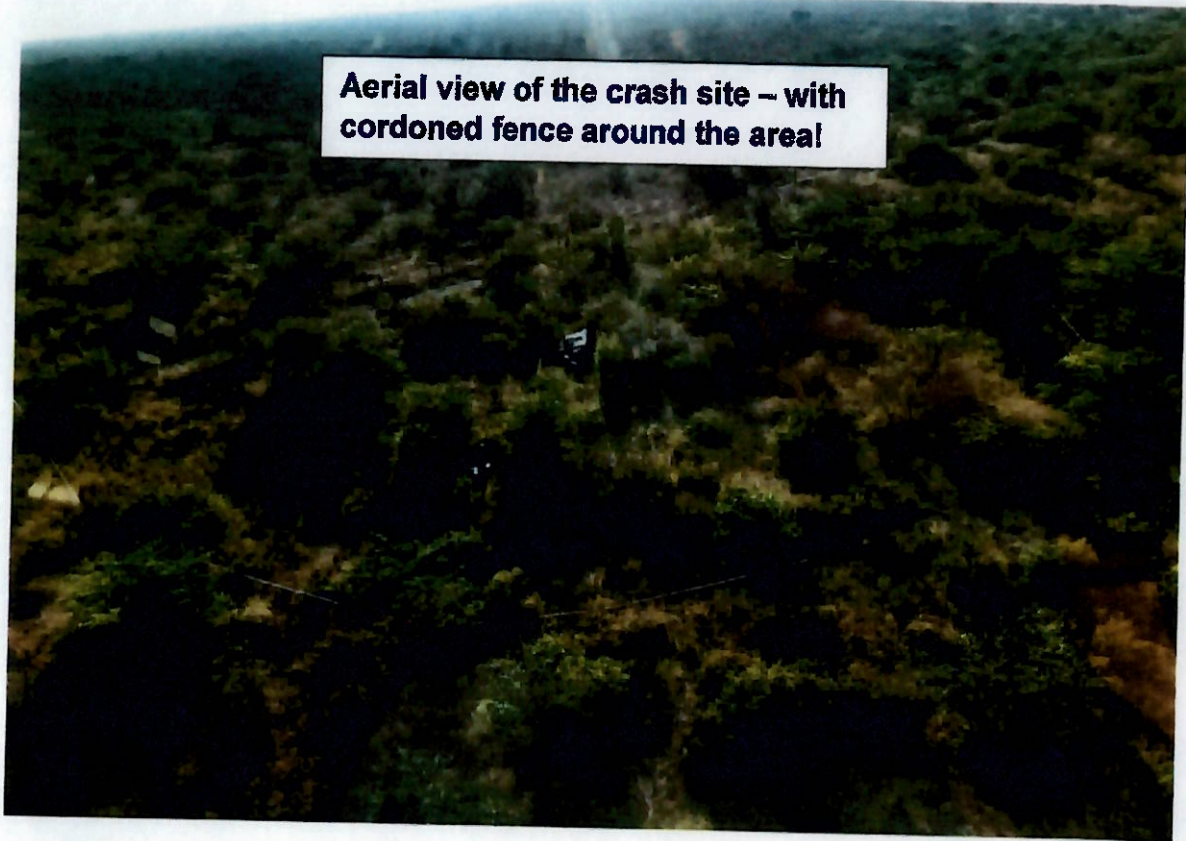
Aerial view of the crash site – with cordoned fence around the area!

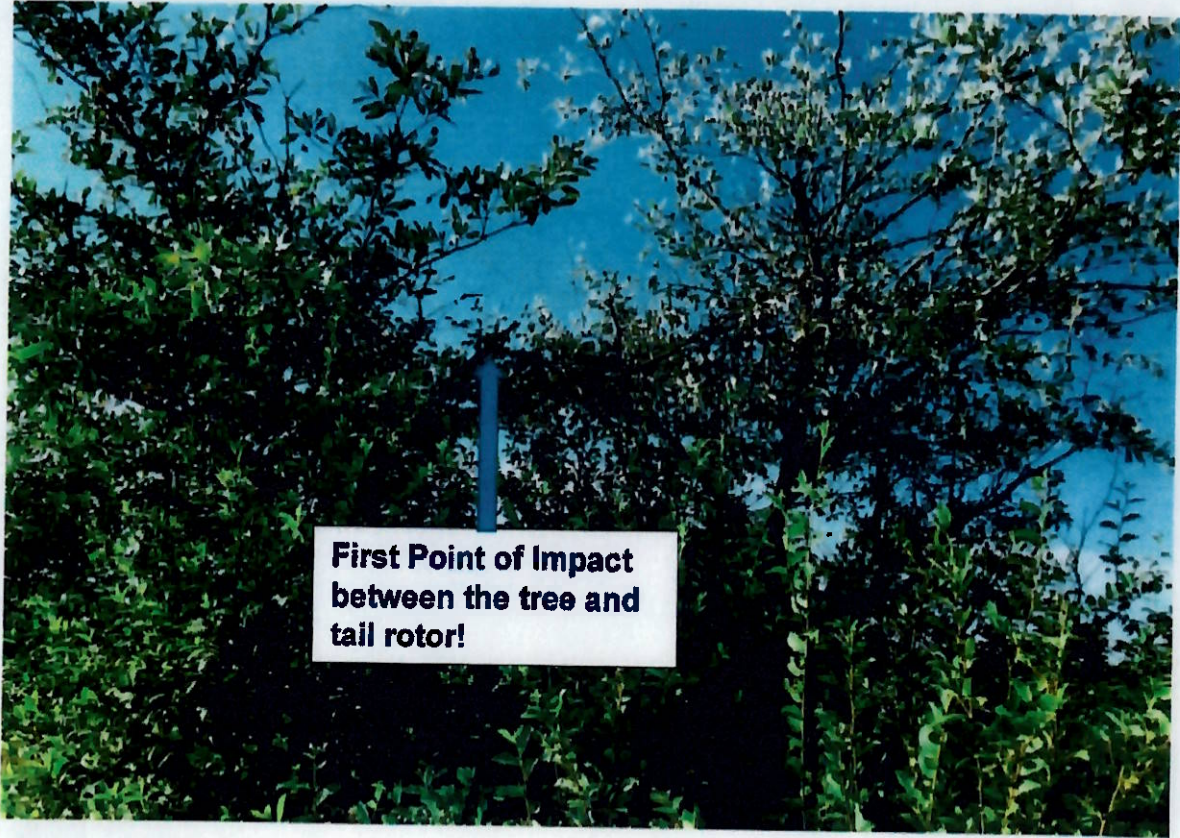
1.12.1 The site investigation revealed that the occurrence aircraft's tail rotor had collided with the terrain (i.e. a tree) while it was flying slightly nose-up. The rotorcraft then spiralled towards the ground but on a somewhat steady dive rather than a sharp vertical descent. From the first point of impact (with the tree) to the first impact with ground, it was a distance of approximately 25 metres. Then after the ground impact, it went ploughing, moving towards the boundary fence. It pulled the fence with it (which action must have further reduced the helicopter's ground speed) and approximately 54 metres length of the fence was affected. The distance covered while moving on the ground to where the wreckage finally rested was approximately 50 metres. The preliminary report is attached as **Appendix 2** to this report.

The main wreckage lying on its port side, with under surface facing south and the helicopter facing eastwards, the same direction it had come from!

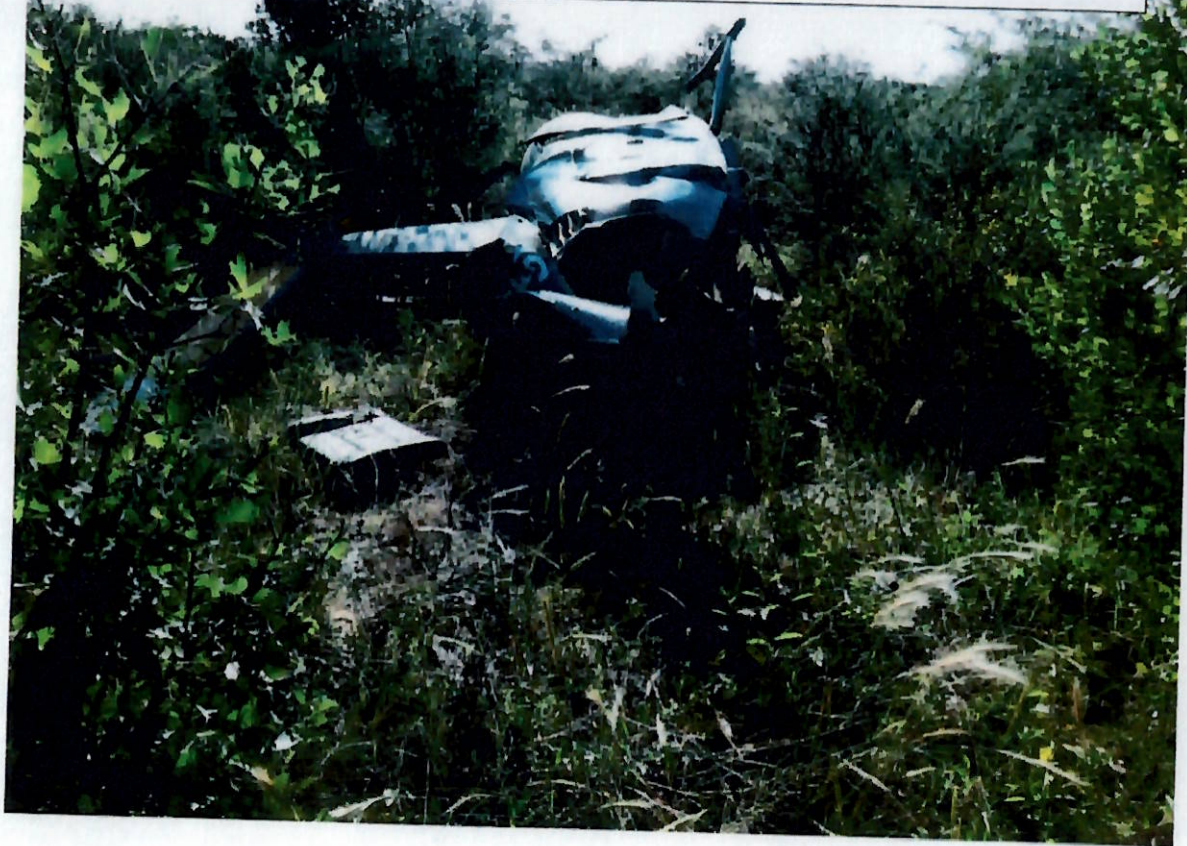
1.12.4 The wreckage showed signs of severe damage to the root of the tail section/boom, with the rest of cabin/fuselage bent, wrinkled and torn. The glass canopy was broken, with the starboard (right-hand side) door not there and only the port door there, but with the glass broken. The seats were found slightly damaged, but both front seat belts were found buckled up. It was also evident that though the aircraft is designed with dual controls, at the time of the site investigation the left-hand side controls seemed to have been disabled or removed (suggesting that the PIC was flying the helicopter from the starboard side and the passenger occupying the port seat). One main rotor blade was sheared off, with wrinkles, bents and tears while the other blade was intact but showing some visible damage. Some of the Wreckage Photographs are attached as **Appendix 4** to this report.

Closer view of the same picture above, showing extensive damage by the root of tail boom.

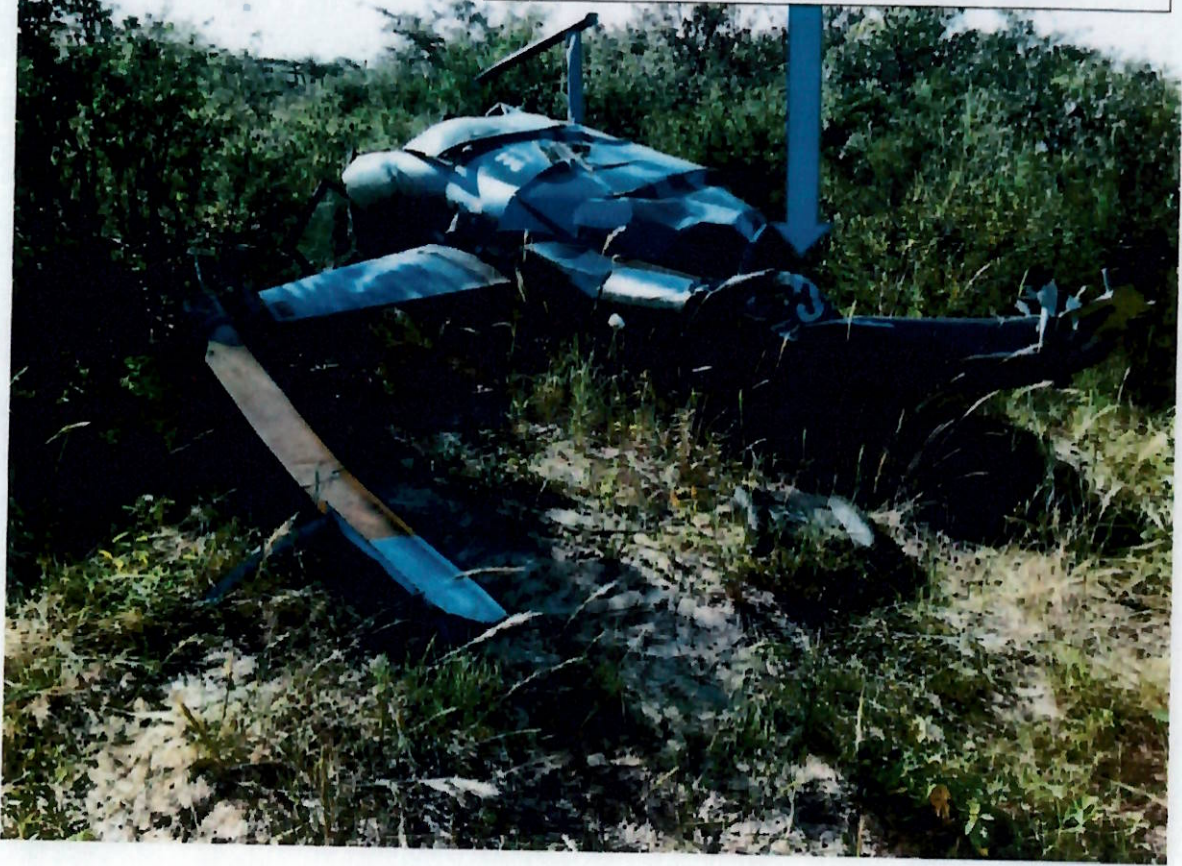
The PIC's Seatbelt
was found buckled
up

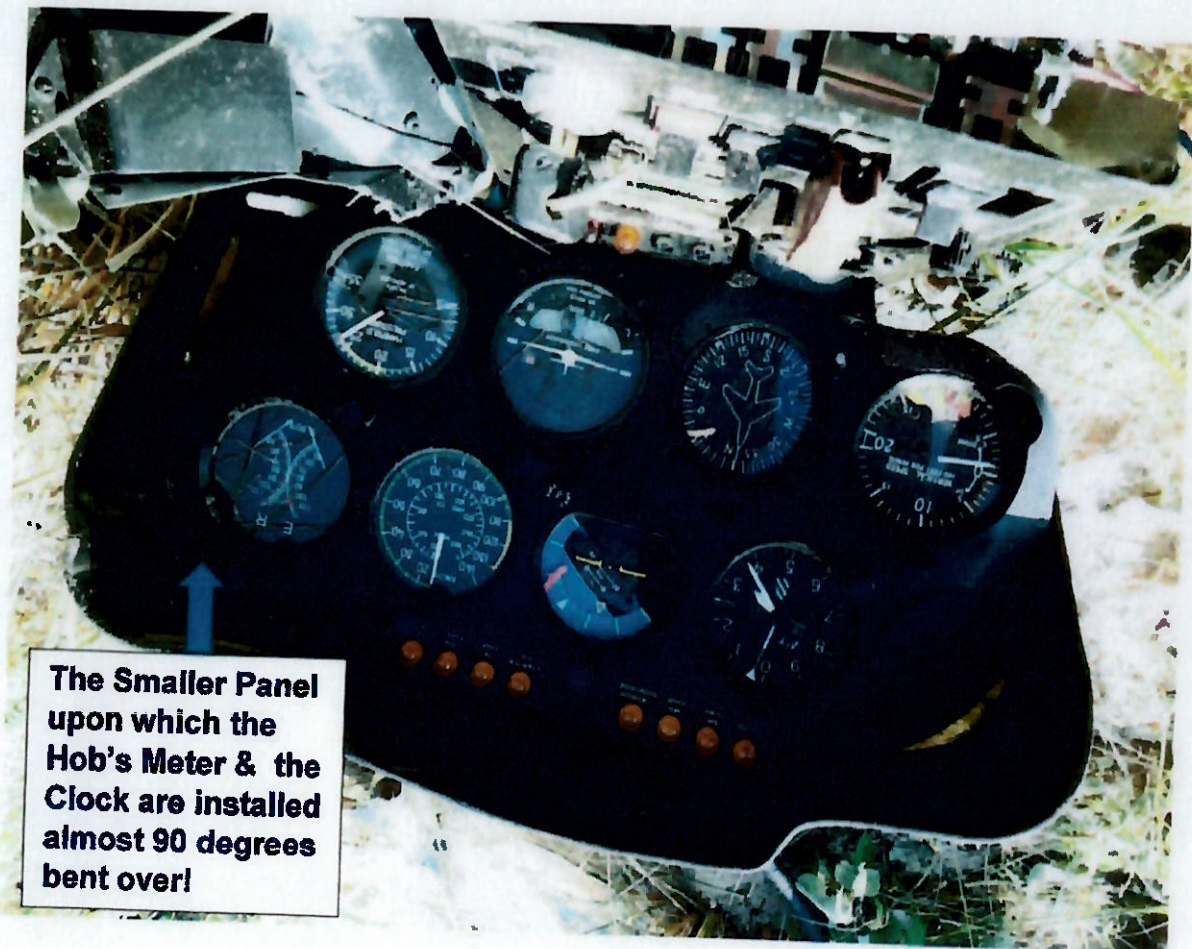
The Smaller Panel upon which the Hob's Meter & the Clock are installed almost 90 degrees bent over!
